# Marine HVAC Condition Report

Riva 75 ft | Dometic Condaria chilled-water system

| REPORT REFERENCE | SCI-MHVAC-CASE-001 | SYSTEM | Marine HVAC / chilled water |

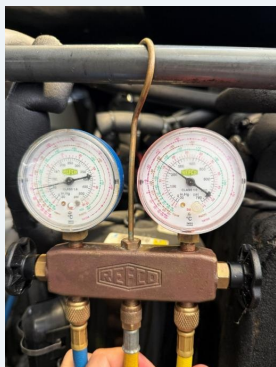
### PRESSURE MEASUREMENT

| Circuit | Load current | Compressor temp. | High-side pressure | Low-side pressure |
| 1 | 19.2 A | 43.0 deg C | 245 psi | 65 psi |
| 2 | 18.6 A | 66.8 deg C | 260 psi | 70 psi |
| 3 | 19.2 A | 43.7 deg C | 240 psi | 70 psi |

Manifold evidence captured the refrigerant-side operating condition.

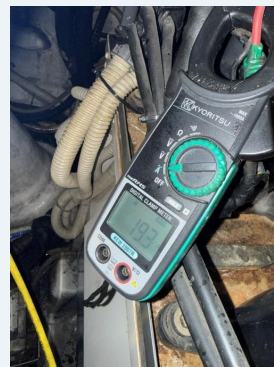
### ELECTRICAL LOAD VERIFICATION

| Indicator | Recorded evidence | Interpretation |
|---|---|---|
| Reported maximum compressor load | 20 A | Operating current was close to the reported maximum on all three circuits. |

Clamp-meter evidence linked the recorded current to an operating circuit.

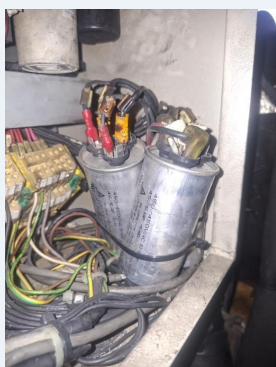
### ELECTRICAL DEGRADATION

| System | Evidence observed | Technical consequence |
|---|---|---|
| Electrical | Missing terminal covers, overheated harnesses, corroded capacitors and poor mounting. | High reliability risk with localized overheating and fire potential. |

Corroded and poorly mounted capacitor terminations supported high-priority panel repair.

| Priority | Observed risk | Required control |
|---|---|---|
| CRITICAL | Overheated or corroded wiring and unsecured capacitors. | Isolate unsafe circuits; replace damaged conductors, terminals, covers and mounts before extended operation. |

1. Make the electrical installation safe: replace damaged wiring, terminals, covers and capacitor mounts; clean and test the panel.
2. Pressure-test the corroded heat exchanger; renew it if damage is confirmed, then flush the chilled-water circuit, repair leaks and refill with specified treated fluid.
3. Descale the condenser and seawater circuit; clean the strainer and verify pump flow after service.
4. Recondition or replace degraded pumps and renew damaged hoses, elbows, clamps and inaccessible plumbing arrangements.
5. Service fan-coil units, replace damaged filters, clean coils and blowers, clear drains and disinfect affected zones.
6. Verify refrigerant, oil and component compatibility before charging; commission the complete system under stabilized load and issue measured close-out results.

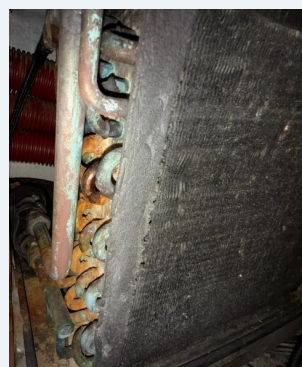
### AIR-SIDE RESTRICTION

| System | Evidence observed | Technical consequence |
|---|---|---|
| Air side | Dirty coils, damaged filters, weak airflow, no-cooling zones and biological odor. | Reduced capacity, poor indoor air quality and condensate/drain risk. |

Heavy coil fouling and corrosion matched the recorded airflow and cooling imbalance.

| Priority | Observed risk | Required control |
|---|---|---|
| MEDIUM | Dirty or corroded fan-coil units and biological odor. | Clean, disinfect, restore drainage and verify airflow and supply temperature by zone. |

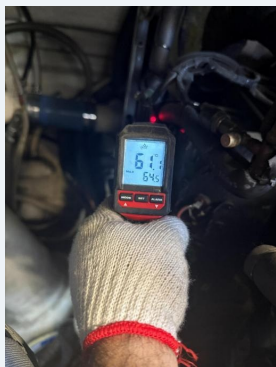
### LINE-TEMPERATURE VERIFICATION

A handheld meter documented a recorded 61 deg C temperature at the chiller circuit.

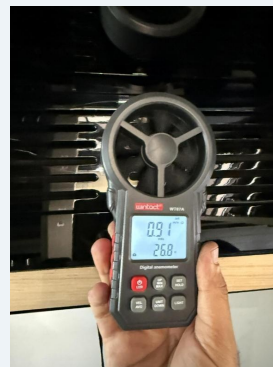
### AIR-DISTRIBUTION VERIFICATION

| Indicator | Recorded evidence | Interpretation |
|---|---|---|
| Representative outlet air | 17.7 to 26.8 deg C | Wide spread confirmed inconsistent zone performance. |
| Representative outlet velocity | 0.91 to 2.38 m/s | Large variation supported airflow restriction and blower/coil maintenance findings. |

Grille measurement recorded low airflow and elevated supply-air temperature in an affected zone.
