SILENT CORE INDUSTRIES | MARINE HVAC REPORT

# High-Pressure Trip Investigation

Majesty 100 ft | MAR-IX three-chiller system

| REPORT REFERENCE | SCI-MHVAC-CASE-002 | SYSTEM | Marine HVAC / chilled water |

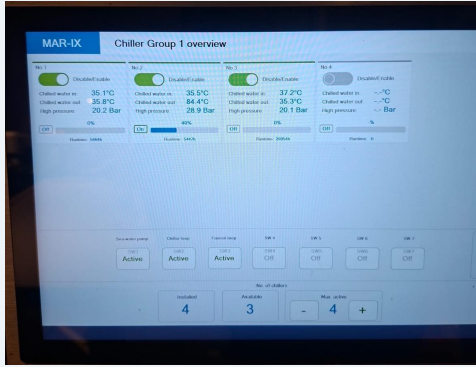
### CHILLER GROUP INTERFACE

The MAR-IX controller documented the multi-chiller configuration used in the investigation.

- The controller view supports a three-chiller system context rather than a single-unit fault narrative.
- Water-side restoration was documented independently from refrigerant-side pressure stabilization.

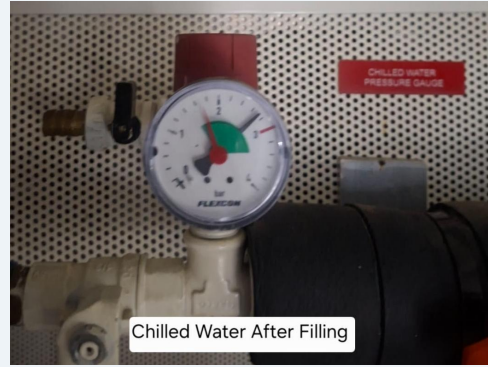
### CHILLED-WATER PRESSURE RECOVERY

| Item | Specification | Field note |
|---|---|---|
| Water-side baseline | Chilled-water loop recorded at approximately 0.2 bar; reported target 2-3 bar | Demonstrates why refill and air removal were a necessary first corrective step. |

Gauge evidence documented the water-side condition after filling and air removal.

| Stage | Evidence | Response |
|---|---|---|
| Initial water-side check | Chilled-water pressure approximately 0.2 bar against a reported 2 to 3 bar operating target; trapped air present. | Refilled the loop and air-bled the circuit. |
