SILENT CORE INDUSTRIES | MARINE HVAC REPORT

# Corrosion and Leak Assessment

Sunseeker 73 ft | Dometic three-chiller chilled-water system

| REPORT REFERENCE | SCI-MHVAC-CASE-003 | SYSTEM | Marine HVAC / chilled water |

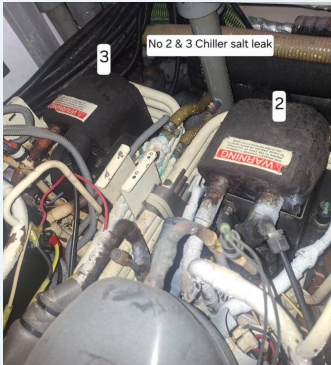
### MULTI-CIRCUIT SALT EXPOSURE

Deposits around two chiller assemblies indicated a shared environmental or leak mechanism.

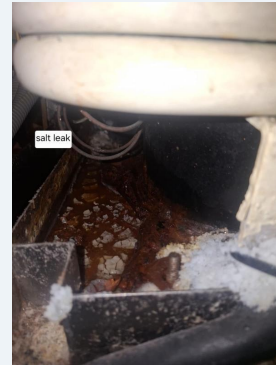
### ACTIVE CONTAMINATION PATH

Visible saltwater residue and corrosion were present in the machinery base area.

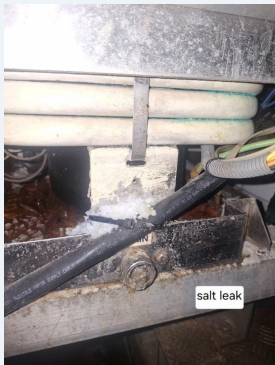
### CORROSION PROPAGATION

Salt deposits extended beyond a single component and affected adjacent structure and pipework.

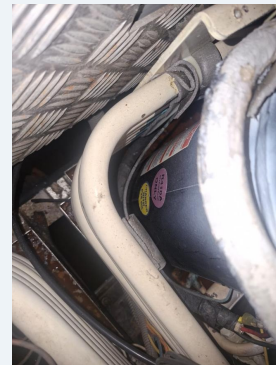
### REFRIGERANT-CIRCUIT CONDITION

| Subsystem | Recorded condition | Required next decision |
|---|---|---|
| Chiller circuit 1 | Possible internal water ingress, heavy salt deposits, general corrosion, clogged drainage and poor wiring insulation. | Remove for controlled strip inspection; confirm internal leak path and contamination extent. |

Close-up evidence supported removal and off-system confirmation before a repair decision.

1. Isolate the most damaged chiller and remove it for controlled inspection in accordance with manufacturer and refrigerant-handling procedures.
2. Confirm or reject internal leakage using appropriate pressure, vacuum-hold and contamination checks before selecting repair or replacement.

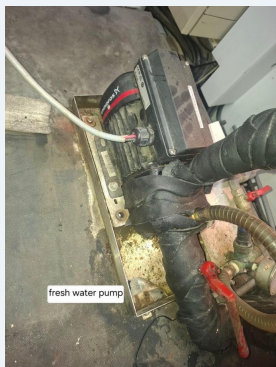
### FRESHWATER PUMP AND PIPEWORK

| Subsystem | Recorded condition | Required next decision |
|---|---|---|
| Freshwater circuit | Pump operating, but installation location was unsuitable; hose/clamp leakage observed. | Repair leaks and review relocation for access and protection. |

Field evidence documented leakage and an unsuitable pump installation condition.

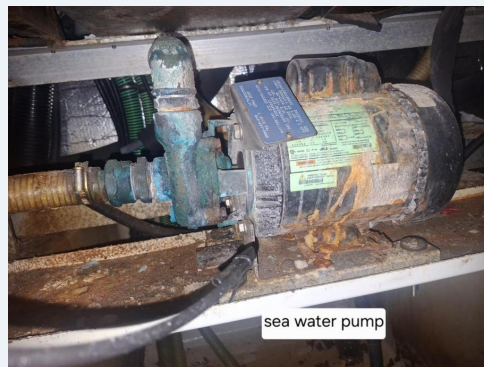
### SEAWATER PUMP CORROSION

| Subsystem | Recorded condition | Required next decision |
|---|---|---|
| Seawater circuit | High marine growth, leaking hose area and advanced corrosion on pump and motor. | Stop the water source, clean the circuit and dismantle/assess the pump for repair or replacement. |

Advanced corrosion affected the seawater pump body, motor and mounting area.
